Property Inspection Report

Client(s): **NC Modernist Houses**
Property address: **2614 Morganton Rd**
Fayetteville NC
Inspection date: **Wednesday, November 20, 2013**

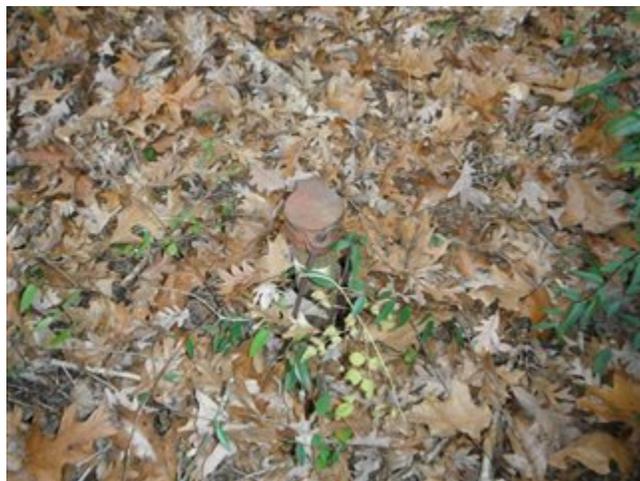
Photo 43

3) Repair/Replace, Evaluate - Evidence of one or more possible abandoned underground oil tanks was found (vent pipe, metal supply lines, etc.). The client(s) should determine if underground oil tank(s) exist on this property, and if tank(s) have been removed or legally decommissioned.

- Have any non-decommissioned, abandoned underground oil tanks legally decommissioned or removed as necessary.
- Have the soil tested for oil contamination.
- Have contaminated soil removed as necessary

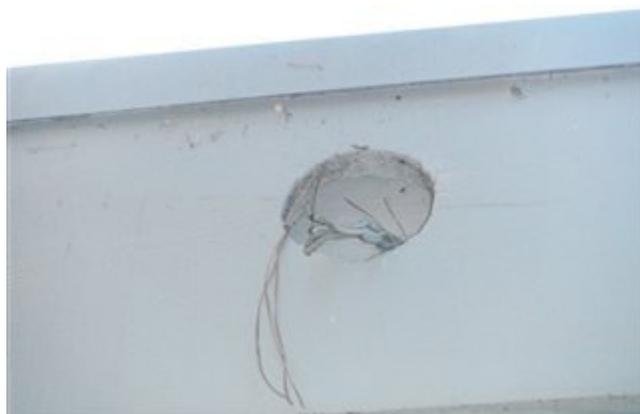
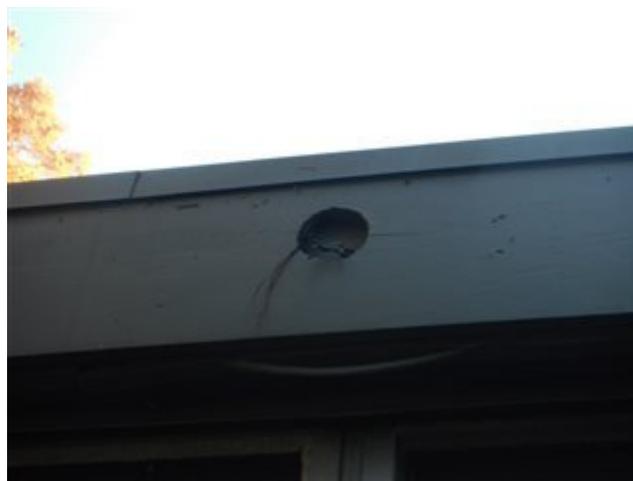
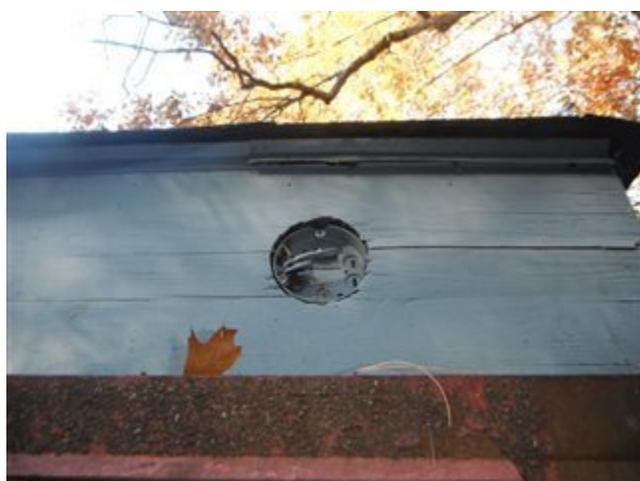
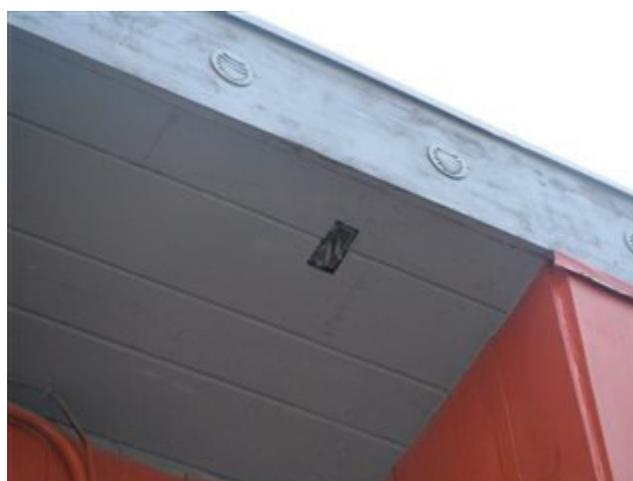
8) Safety, Repair/Replace, Evaluate - One or more sections of wiring that weren't terminated were found around the house at old light fixtures. This is a potential safety hazard due to the risk of shock. A

qualified electrician should evaluate and repair as necessary. For example, cutting the wire to length and terminating the wire with wire nuts in a securely anchored, covered, properly sized junction box.

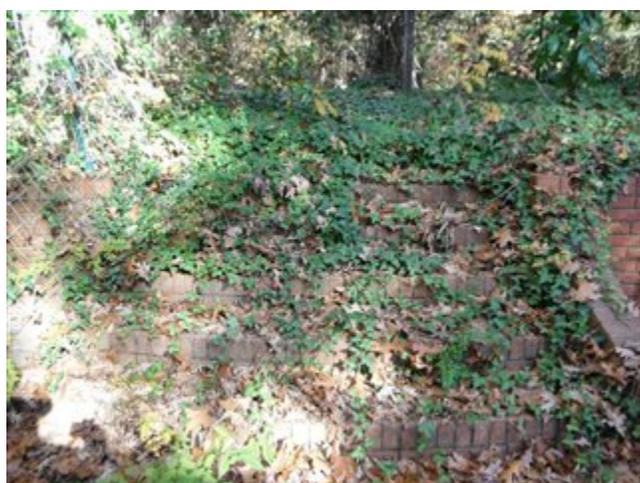
Photo 42

9) Safety, Repair/Replace - One or more flights of stairs with more than two risers have no handrail installed. This is a safety hazard. A qualified contractor should install graspable handrails that your hand can completely encircle at stairs where missing, and as per standard building practices.

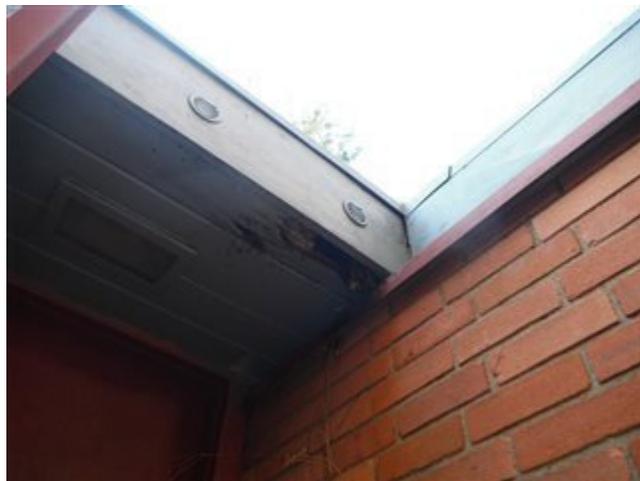
Photo 6

10) Repair/Replace, Evaluate, Damage - Rot was found in one or more areas on soffit boards above

the back door. A qualified contractor should evaluate and make repairs as necessary, replacing all rotten wood.

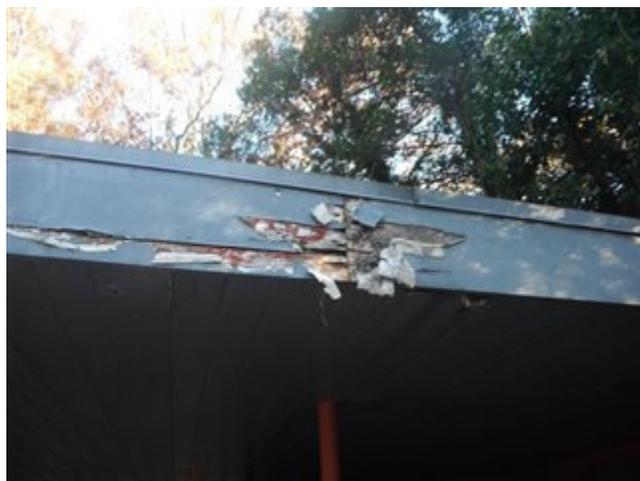
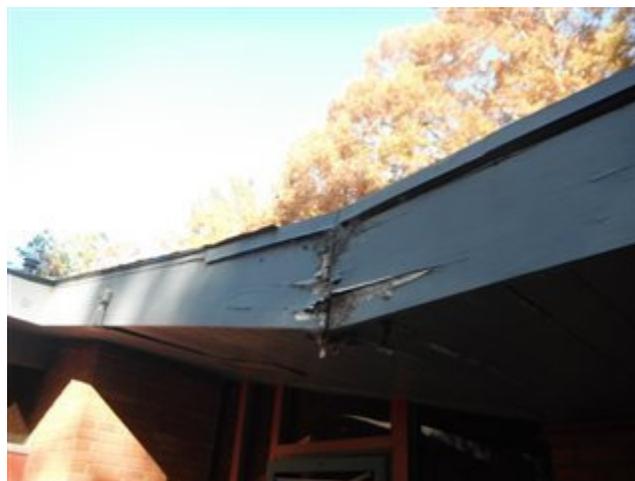
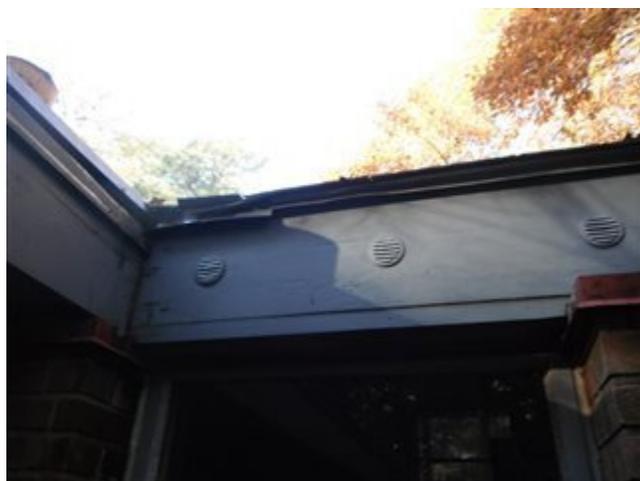
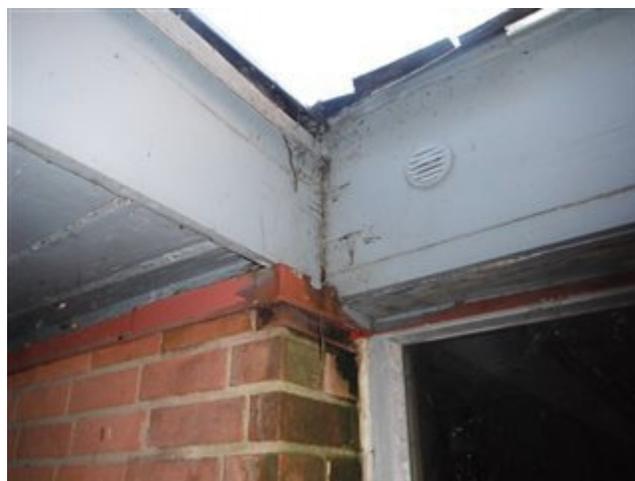
11) Repair/Replace, Evaluate, Damage - Rot was found in one or more areas on fascia boards. It appears that the damage was from past roof leaks. A qualified contractor should evaluate and make repairs as necessary, replacing all rotten wood.

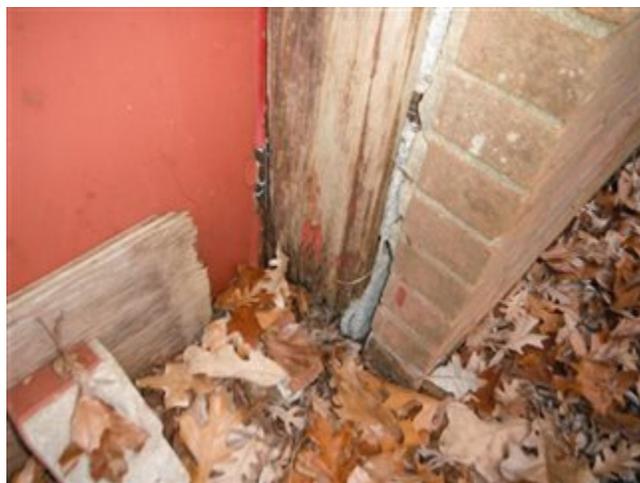
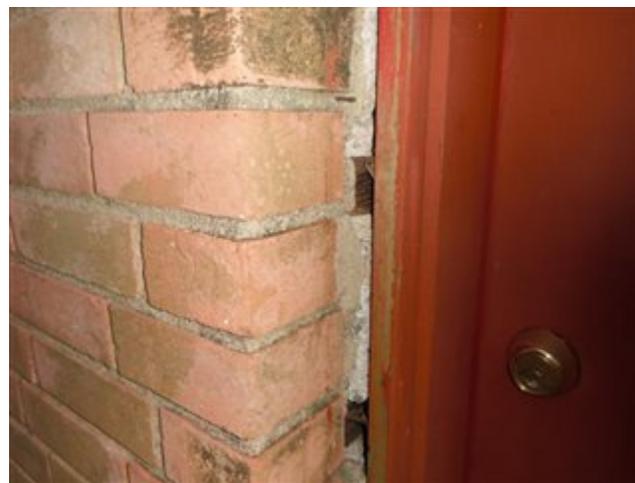
12) Repair/Replace, Evaluate - The back storage room door and frame are damaged from age and

weather. A qualified contractor should evaluate and repair such as replacing the door frame and sealing around the door.

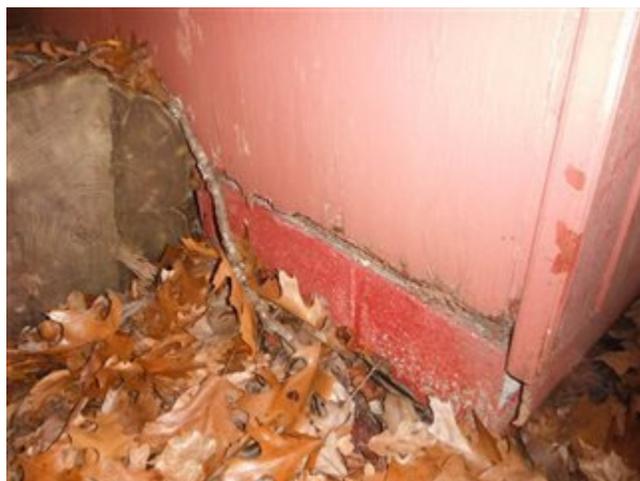
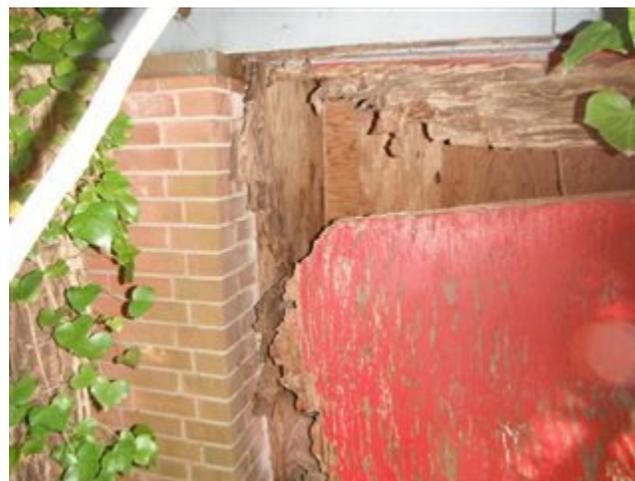
13) Repair/Replace, Evaluate - The back section of the side storage rooms is damaged from age and moisture. Recommend having a qualified contractor evaluate and replace all damaged wood.

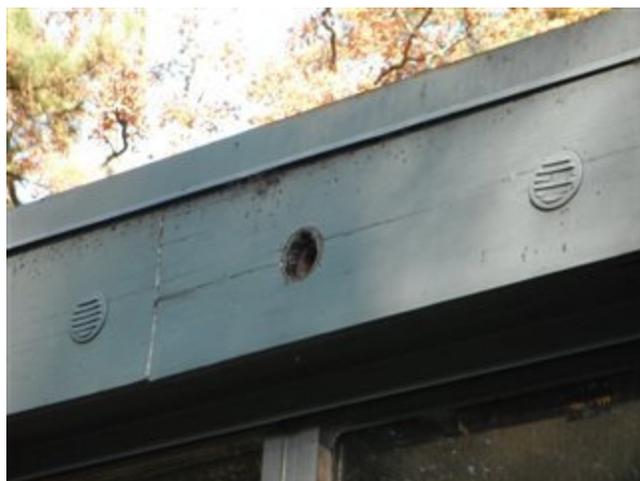
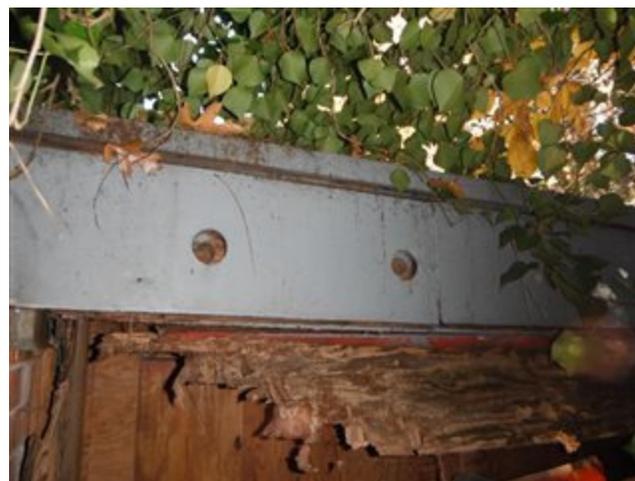
Photo 18**Photo 22**

14) Repair/Replace - One or more soffit vent screens are missing and/or deteriorated. Birds and vermin may enter the attic because of this. Screens should be replaced or repaired where necessary, or installed where missing.

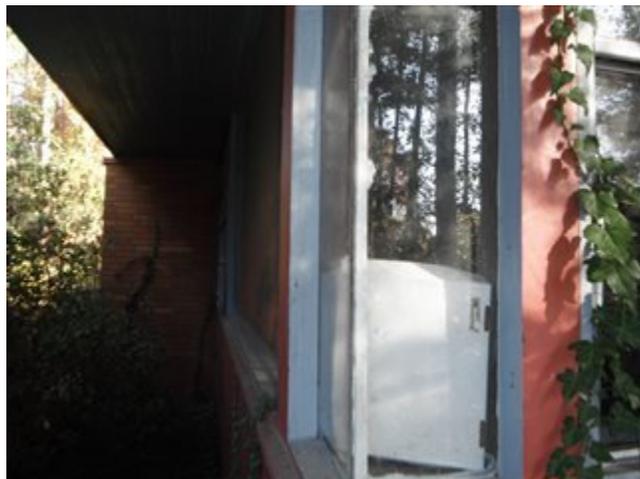
**Photo 19**

15) Repair/Replace - There are several corners of the house that have windows butted together and sealed with caulk. Caulk is a temporary fix and a qualified contractor should evaluate and fix the design flaw.

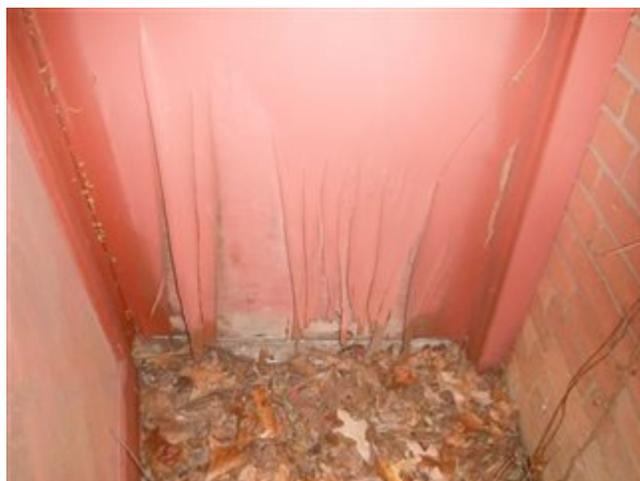
**Photo 7**

16) Repair/Replace - The back exterior door is damaged and a qualified contractor should replace the door.

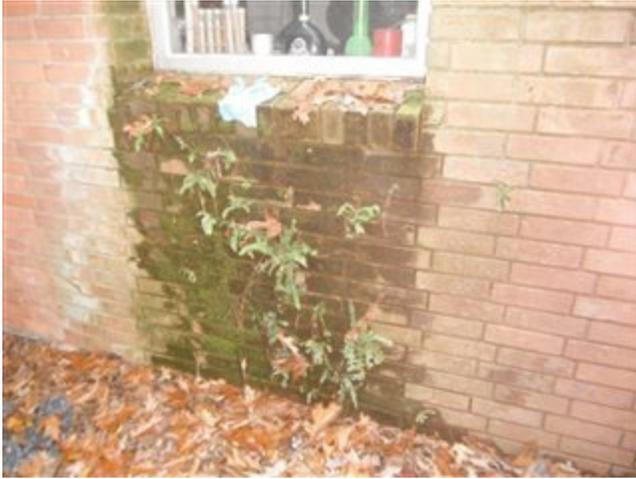
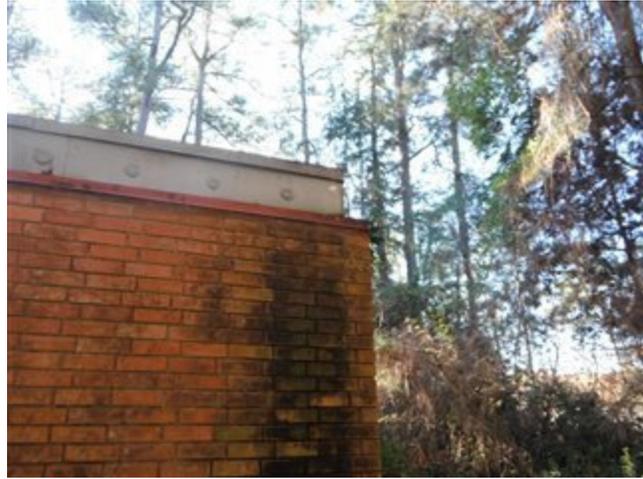
17) Repair/Replace - Because of the design of the house there are areas where the roof water is flowing off the flat roofs and down to window sills and veneered areas. Splashing water back toward wood framed areas can damage building components. The clients may want to have gutters installed.

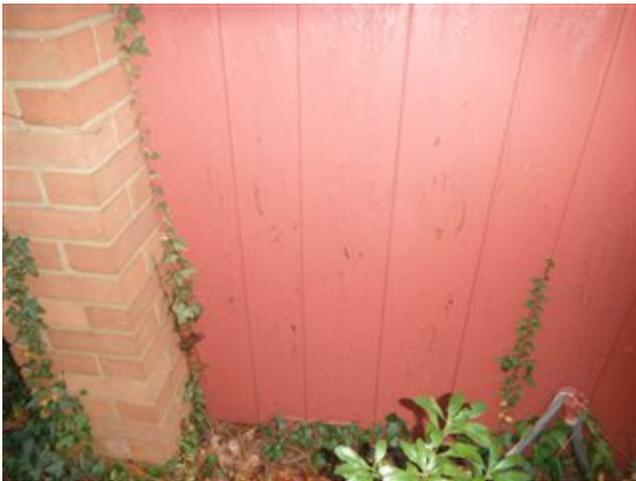
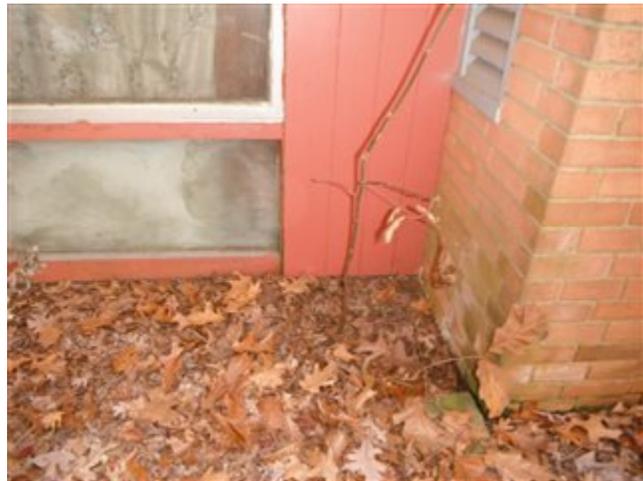
18) Repair/Maintain - Soil is in contact with or less than six inches from siding and/or trim. This is a conducive condition for wood destroying insects and organisms. Soil should be graded and/or removed as necessary so there are at least six inches of space between the siding and trim and the soil below.

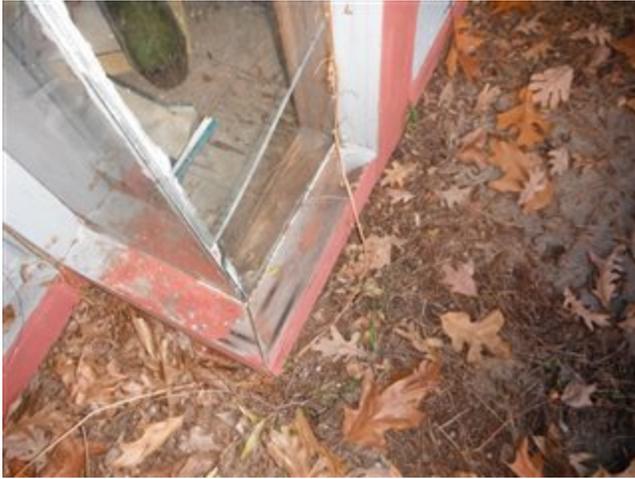
Photo 40

20) Maintain - The exterior finish in some areas is failing. A qualified contractor should prep (pressure wash, scrape, sand, prime caulk, etc.) and repaint or restain areas as needed and as per standard building practices.

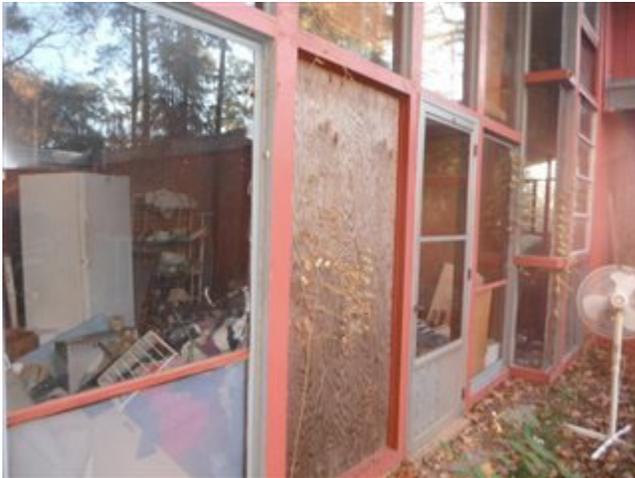
Photo 10

21) Comment - A back sun room window is missing. The clients may want the window replaced.

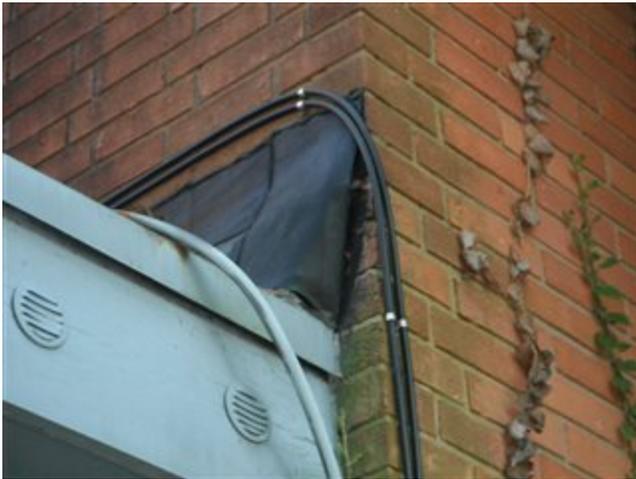
Photo 44

23) Repair/Replace, Evaluate - One or more sections of flashing at the base of the chimney are deteriorated and/or substandard. Leaks may occur as a result. A qualified roofing contractor should evaluate and repair as necessary.

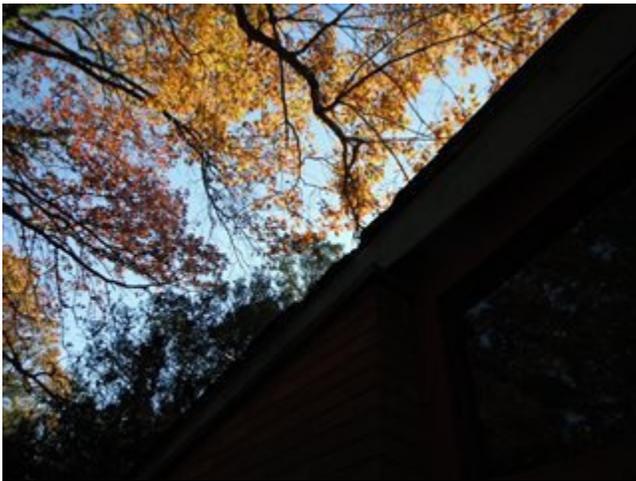
Photo 41

24) Repair/Replace, Evaluate - One or more composition shingles are damaged, deteriorated and/or missing, and should be replaced. Leaks may occur as a result. A qualified roofing contractor should evaluate and make repairs as necessary.

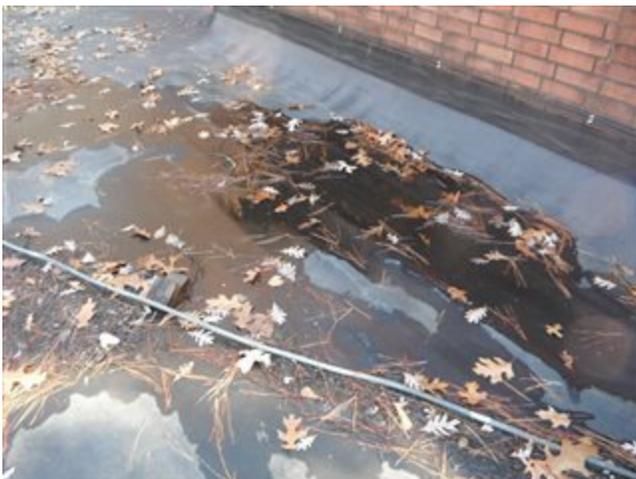
Photo 38

25) Repair/Replace, Evaluate - Standing water was found on the flat roof. It should evaporate within 48 hours after it rains. If standing water remains after 48 hours, then the roof installation is likely substandard. A qualified roofing contractor should evaluate and repair if necessary to prevent prolonged standing water.

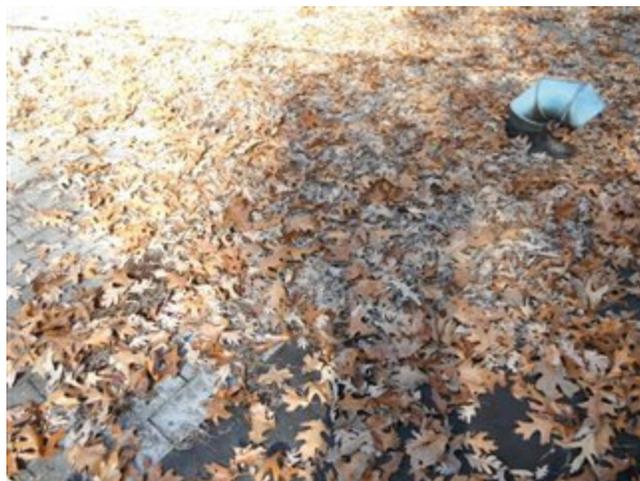
**Photo 33**

27) Maintain - Debris such as leaves, needles, seeds, etc. have accumulated on the roof. This is a conducive condition for wood destroying insects and organisms since water may not flow easily off the roof, and may enter gaps in the roof surface. Leaks may occur as a result. Debris should be cleaned from the roof now and as necessary in the future.

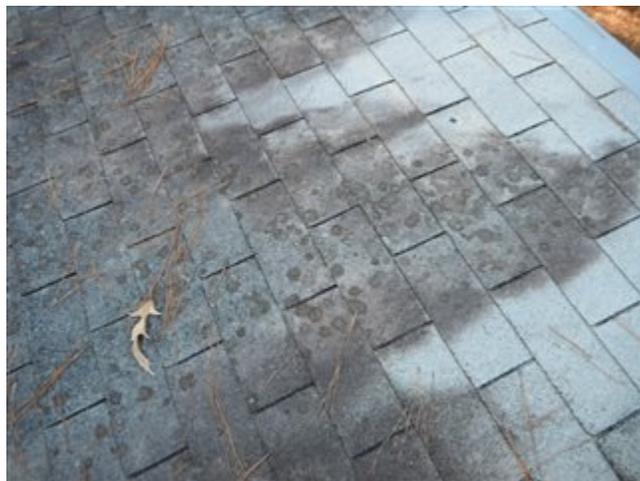
**Photo 35**

28) Maintain - Moss is growing on the roof. As a result, shingles may lift or be damaged. Leaks may result and/or the roof surface may fail prematurely. This is a conducive condition for wood destroying insects and organisms. Efforts should be taken to kill the moss during its growing season (wet months). Typically zinc-based chemicals are used for this, and must be applied periodically. For information on various moss treatment products and their pros and cons, visit <http://bryophytes.science.oregonstate.edu/page24.htm>

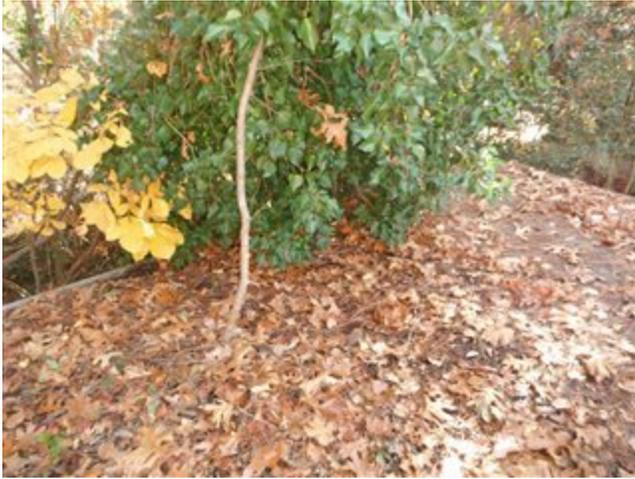
Photo 37

29) Maintain - Trees are overhanging roof and are within 10 feet of roof vertically. This is a conducive condition for wood destroying insects and organisms since organic debris such as leaves or needles are more likely to accumulate on the roof surface. Accumulated debris may cause water to enter gaps in the roof surface and leak into attic and/or interior spaces. Trees should be pruned so they are at least 10 feet above roof, or don't overhang the roof.

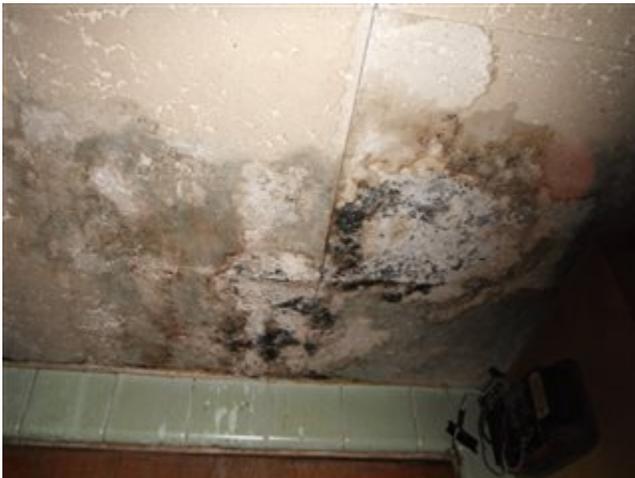
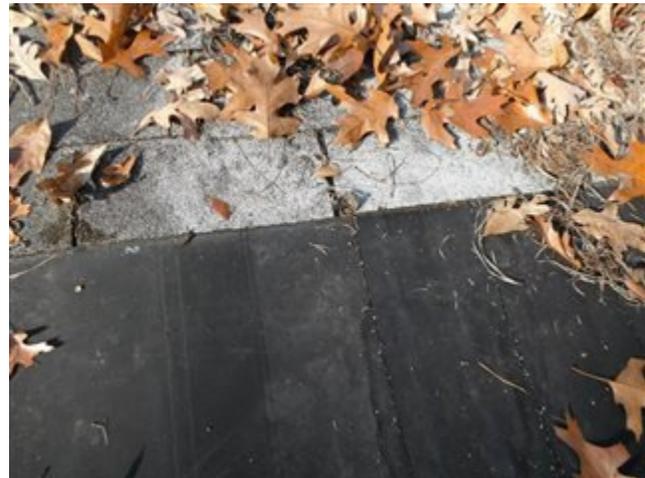
31) - There are damaged ceiling areas under the roof where the shed roof connects to the flat roof. It appears that the transition area was not sealed properly and leaks have occurred. Recommend having a roofing contractor evaluate and repair

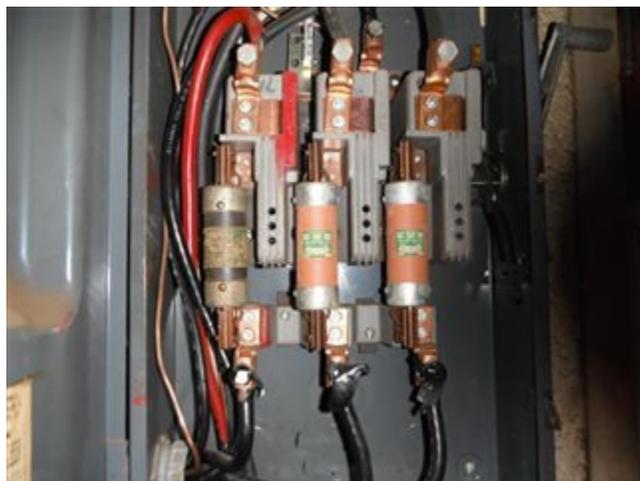
Photo 29

32) Safety, Major Defect, Repair/Replace, Evaluate - The main service panel uses older style fuses. This type of fuse allows anyone to install incorrectly rated fuses, possibly resulting in damage to wiring.

Based on the age and/or appearance of the panel(s) using fuses, and/or deterioration of the panels or components inside, recommend having a qualified electrician replace this panel with a modern panel and circuit breakers. If the panel isn't replaced, then a qualified electrician should evaluate and make repairs as necessary.

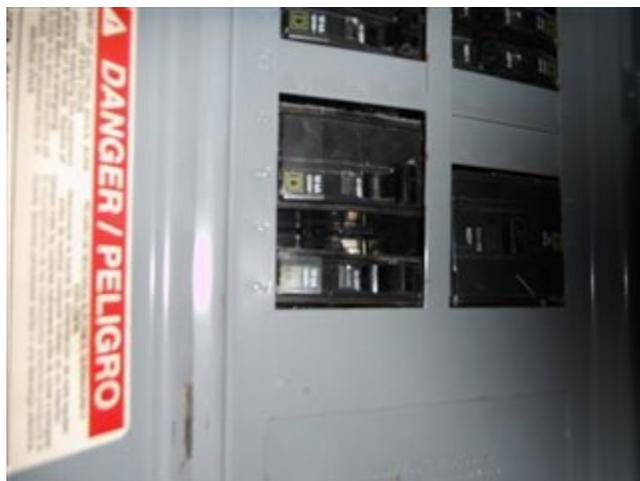
Photo 31

34) Safety, Minor Defect - One or more knockouts have been removed inside the main service panel where no wires and bushings are installed, and no cover(s) have been installed to seal the hole(s). This is a safety hazard due to the risk of fire. A qualified electrician should install knockout covers where missing.

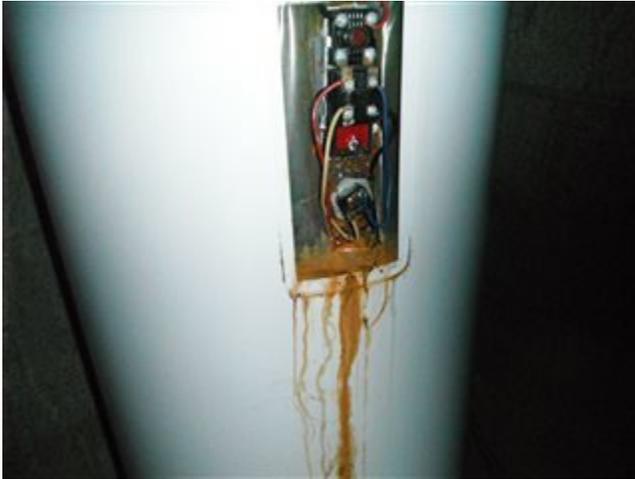
Photo 26

38) Repair/Replace, Evaluate - Corrosion was found in one or more areas on the water heater. The water heater may be failing. A qualified plumbing contractor should evaluate and replace or repair water heater if necessary.

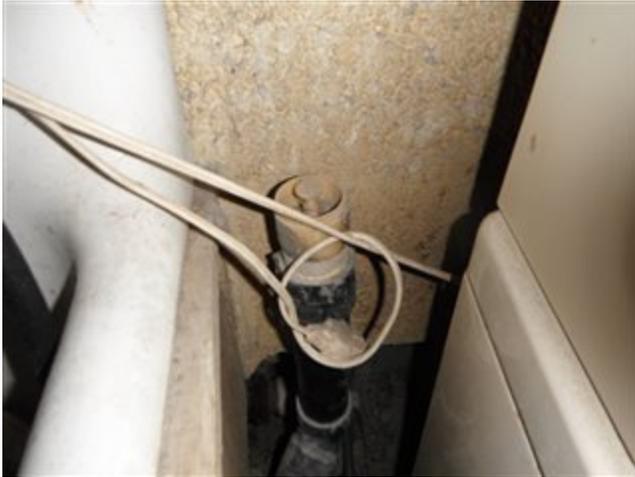
Photo 32

39) Safety, Repair/Replace - The mechanical venting device for the kitchen sink and laundry room is broken. This can allow sewer gas into the house and a plumbing contractor should replace the damaged device.

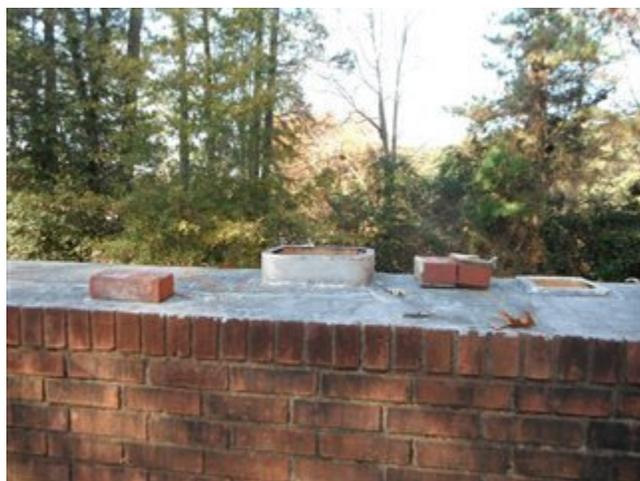
Photo 34

46) Safety, Repair/Replace - One or more chimney flues do not have a screened cover installed. Screened covers prevent the following:

A qualified chimney service contractor should install screened cover(s) where missing. Screens should have holes 1/4 inch or larger.

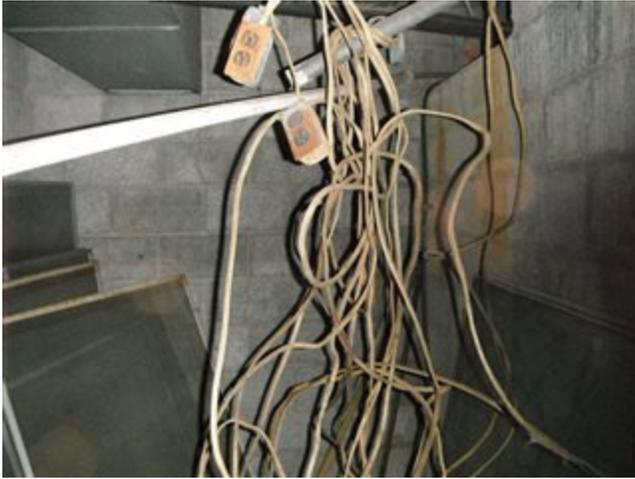
Photo 27

48) Safety, Repair/Replace, Evaluate - Non-metallic sheathed wiring is routed in one or more areas so it is subject to damage, such as on wall or ceiling surfaces. The insulation can be damaged by objects coming in contact with it and/or it being repeatedly moved. This is a safety hazard due to the risk of shock and fire. A qualified electrician should evaluate and repair as necessary. For example, rewire using conduit, or re-routing through wall cavities.

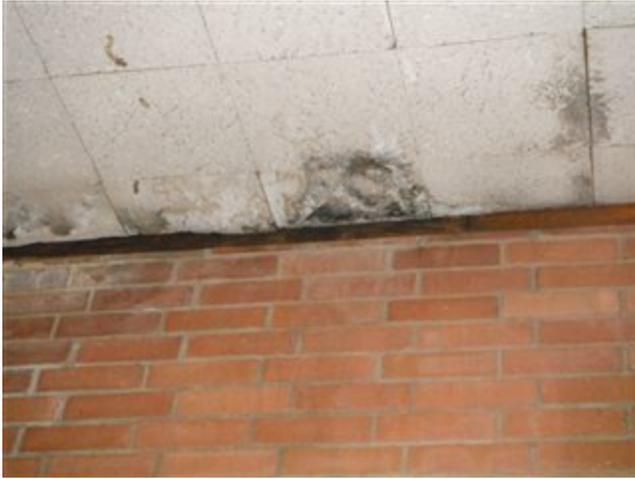
**Photo 25**

57) Repair/Replace, Evaluate - Stains and elevated levels of moisture were found in one or more ceiling areas. The stain(s) appear to be due to roof leaks. A qualified contractor should evaluate and repair as necessary.

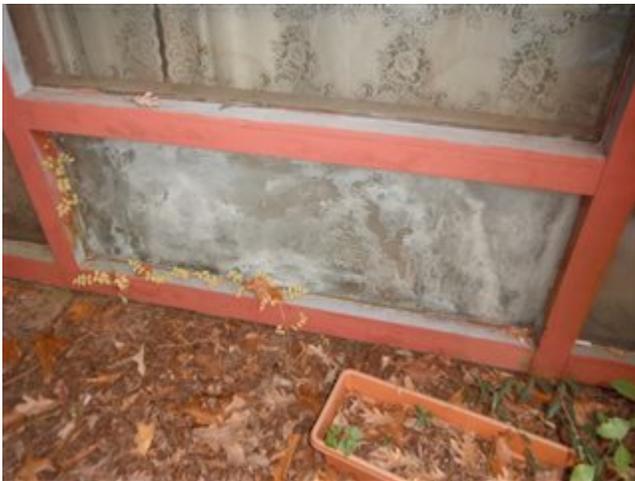
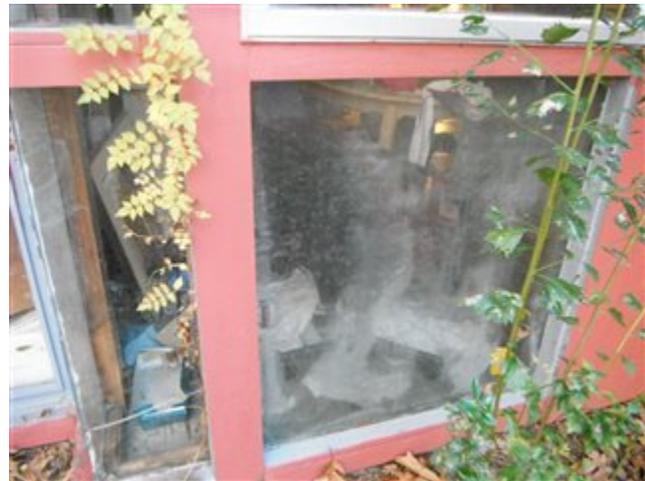
58) Repair/Replace, Evaluate - Seals between double-pane glass in one or more windows appear to have failed based on condensation or stains between the panes of glass. A qualified contractor should evaluate and replace glass where necessary.

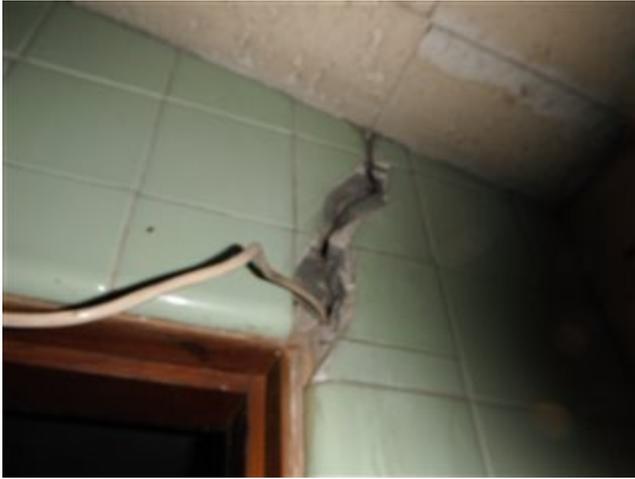
Photo 30

62) Evaluate - There is a large crack in the kitchen masonry wall above the laundry room door. The crack could be from settlement or there could be structural issues at this location. Recommend having a structural engineer evaluate.
